West Basin Municipal Water District

Ocean Water Desalination Pilot Plant Project

**Investigation of Microfiltration & Reverse Osmosis
Seawater Desalination**

Final Report

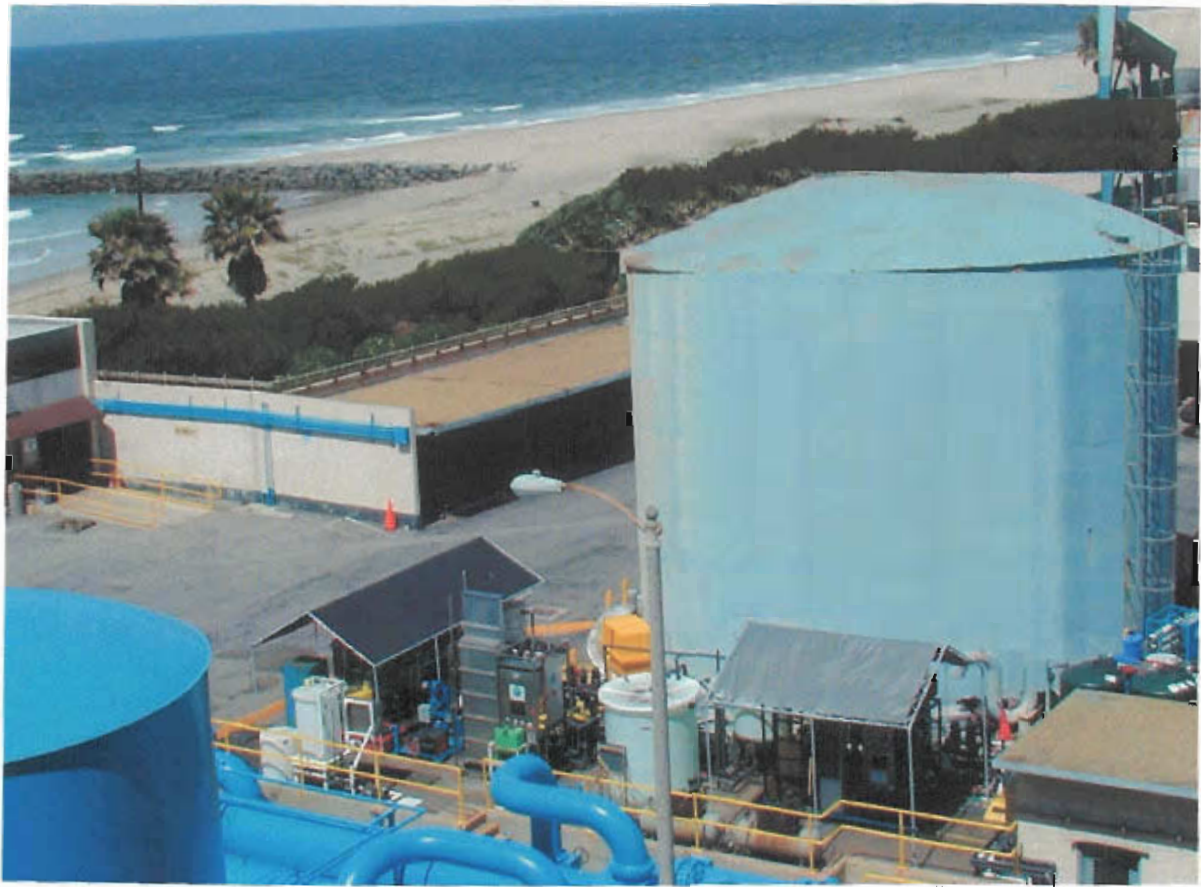
Figure 1 - Test Equipment at the El Segundo Power Plant

The testing occurred at the El Segundo Power Generation Plant (Figure 1). Seawater desalination is energy intensive and a full-scale seawater desalination plant co-located with an existing ocean water cooled power plant has two advantages. The first advantage is that power can be purchased at relatively low rates "within the fence" of the power plant. In California, this can result in an energy savings of $\geq \$0.05/\text{kWh}$. In addition, the seawater desalination plant can also utilize the existing intake and outfall structures that allow seawater to be brought into the power plant and returned to the ocean.

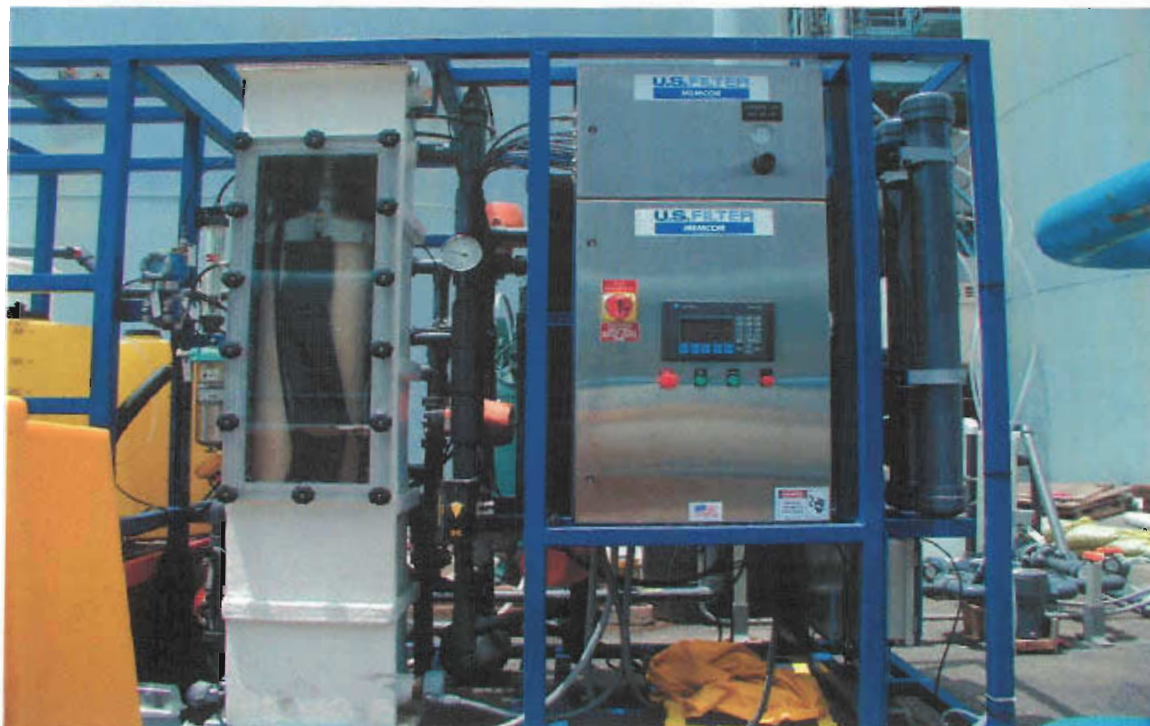
Figure 4 - US Filter CMF-S Microfiltration Pilot System

The US Filter CMF-S system was initiated in June 2002, with the first month used as an equipment troubleshooting period. The first stable run started on July 19. The MF trials are summarized in the following Tables 2 and 3. The testing was divided between different test “trials” and “runs.” A trial is defined here as a significant process change. A run is simply operation between chemical cleaning events, module replacements or operational changes.

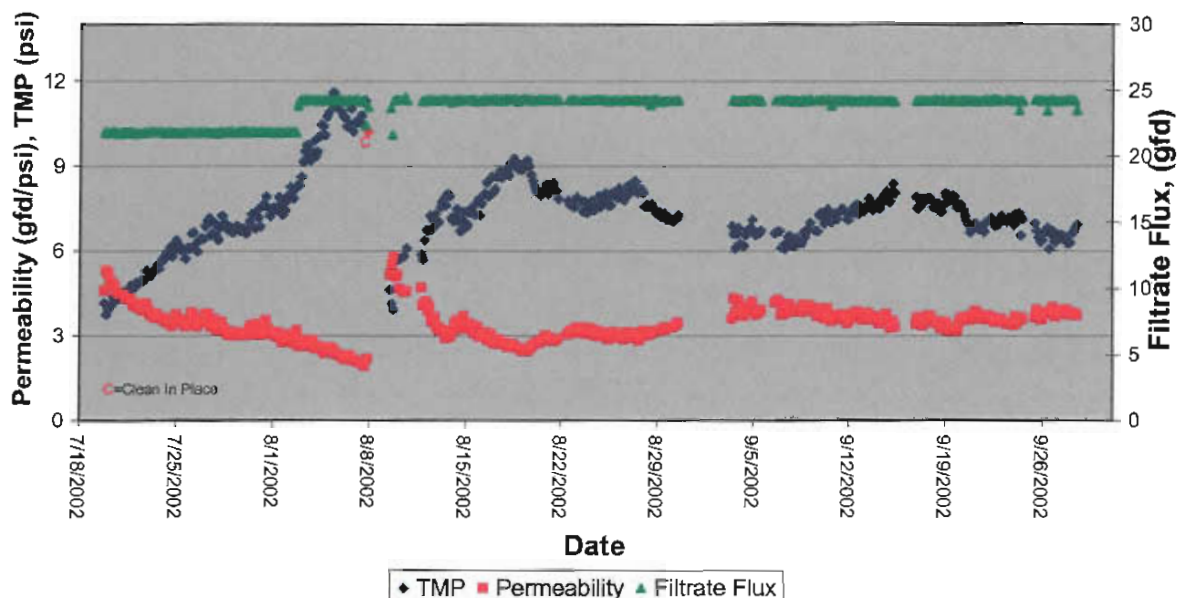
Figure 5 - Permeability of Microfiltration System with Continuous Prechlorination (MF Trial I)

MF runs 1 and 2 were performed with continuous chloramination at conditions indicated in table 3. The MF demonstrated very stable operation during this period. After an initial 3 week run, the MF membrane was cleaned, the flux increased to 24 GFD and the unit was restarted. This 24 GFD run with continuous chloramination lasted over 6 weeks without requiring a chemical cleaning. The continuous chloramination was discontinued following MF Trial I as the NaOCl → MF → NH₄OH → RO process resulted in oxidation of the RO membranes. The bromide ion naturally present in ocean water interfered with the intended formation of chloramine and bromamine was formed. Bromamine is a stronger oxidant than chloramines and the bromamine damaged the downstream RO membranes. See the appendix for further details.

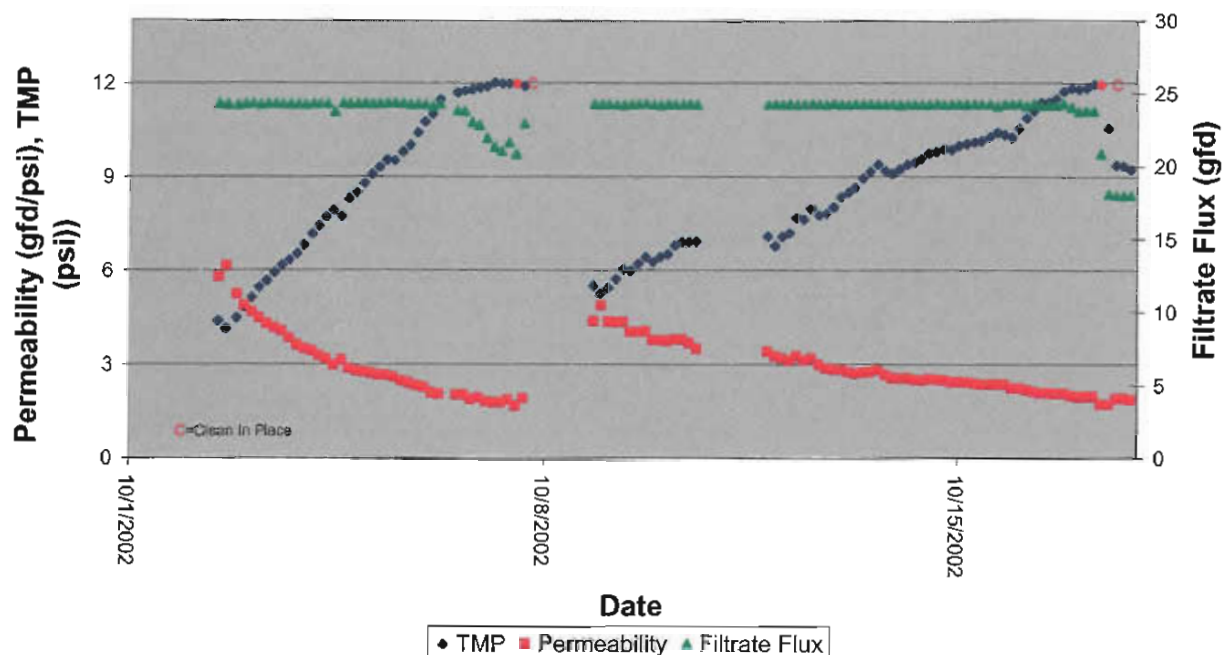
Figure 6 - Permeability of Microfiltration System with No Chlorination (MF Trial II)

Once prechlorination was abandoned, attempts were made to run the US Filter CMF-S system at the same conditions with no chlorination at all. Rapid fouling was observed in two consecutive runs as shown in Figure 6. Note that neither of these runs lasted ten days before reaching terminal permeability. Operation at 24 GFD failed miserably without the chloramination and demonstrated how beneficial the oxidant is to the stable performance of microfiltration membrane process on this feed source.

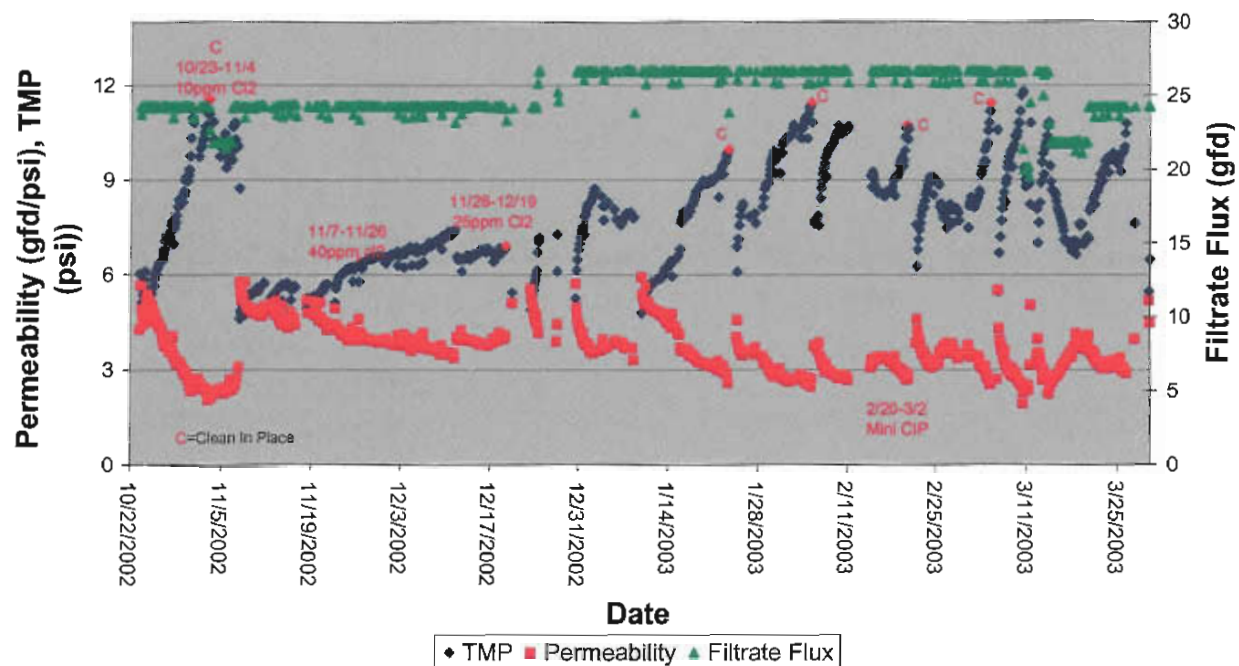
Figure 7 - Permeability of Microfiltration System with Chlorinated Backwashes (MF Trial III)

Recognizing the benefit of chlorine to the MF process but accepting that the attempted chloramination of the feedwater (Trial I) presented an adverse impact on the RO membrane, an alternative approach to the use of chlorine was attempted in MF Trial III. Chlorinated backwashes were implemented. 10 mg/L NaOCl was attempted in every backwash and again rapid fouling was observed as depicted in figure 7. A stable run condition was finally achieved in run #6 by increasing the dose to 40 mg/L NaOCl in every backwash. This run showed a slow fouling rate over two weeks. When the chlorination was decreased from 40 to 25 mg/L NaOCl every backwash in run #7, the MF operated for an additional month without requiring a shut down for a chemical clean in place (CIP).

The filtrate flow was then increased from 22 gpm to 24 gpm for run #8, corresponding to a flux increase from 24 to 25.8 GFD. Numerous attempts failed to demonstrate a run time longer than 3 weeks at this flux. This was compounded by the fact that the CMF-S clean-in-place (CIP) heater was disabled for a period of time and the cleanings done to start runs #10 and #11 did not restore the membrane permeability effectively.

Examination of Figure 7 shows that the “clean” or post “Clean-In-Place” microfiltration permeability’s have declined since January 23, 2003. This is a sign of an ineffective CIP procedure. The problem was initiated when the CMF-S heater failed, and the two subsequent cleans were performed with cool water on January 23 and February 5, 2003. These cleans were not effective as shown in Figure 7 where the clean permeability’s are only 4 GFD/psi, whereas with previous heated CIP’s, the clean permeability’s were consistently ~6 GFD/psi.

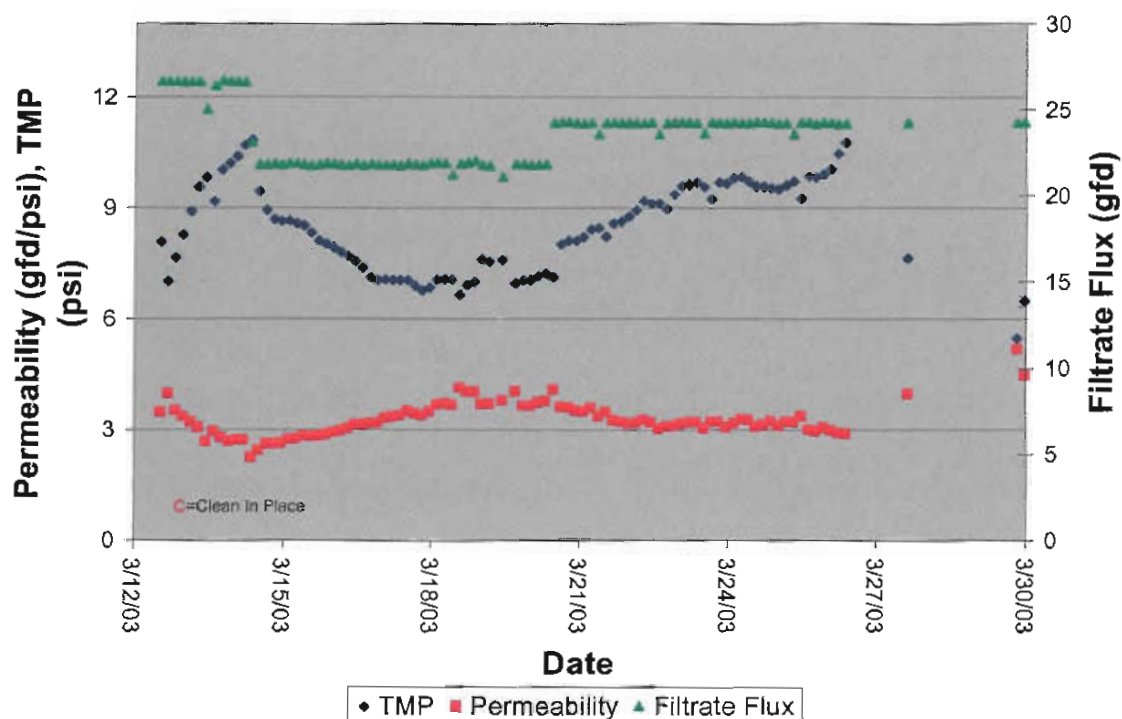
Figure 8 - Microfiltration Run #14 Specific Flux and Permeate Flux

During run 14, the filtrate flow and hence the flux rates were varied as shown in Figure 8.

The run was started with a filtrate flux of ~25.8 GFD and demonstrated rapid fouling, similar to the previous runs. Dropping the flux down to ~22 GFD resulted in an improvement in permeability. Subsequently, the flux was increased to ~24 GFD and the fouling rate increased. Close examination of this data reveals that the acceptable filtrate flux on this water is 22 GFD to 24 GFD with these original CMF-S membranes.

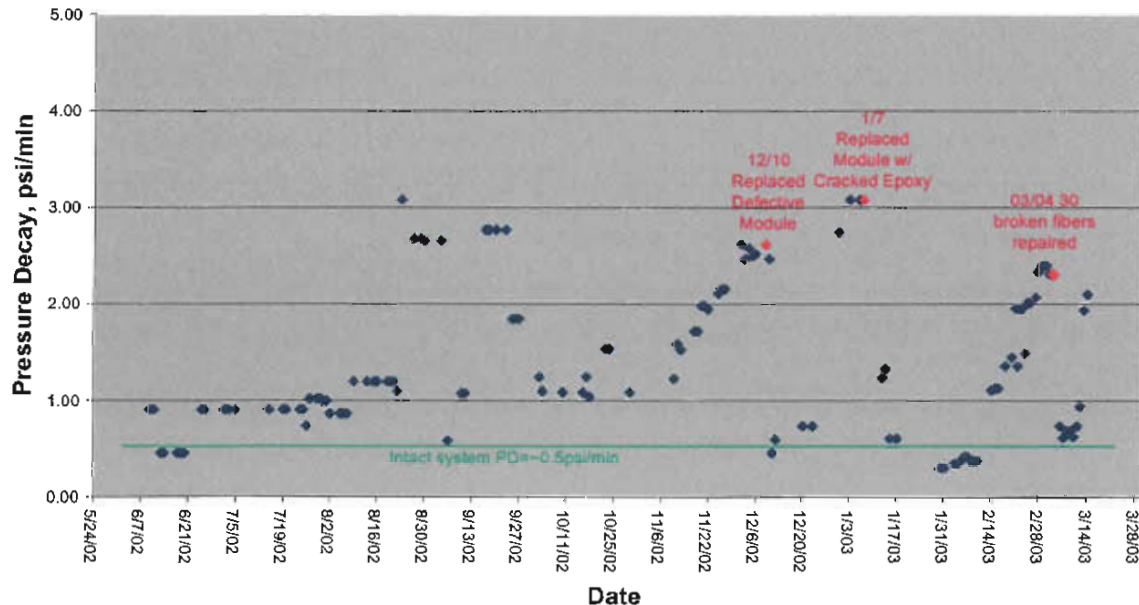
Figure 9 - US Filter Microfiltration Unit Pressure Decay Test Results

Broken fibers were easily detected during the manually initiated pressure decay test (PDT). During the PDT, the unit was isolated and the lumen (filtrate) side of the modules is drained. Air was then injected to the lumen at 15 psi, and then a valve on the feed side was opened to atmosphere. Intact wetted fibers retain the air pressure as the pressure decay rate across an intact fiber is diffusion controlled. Broken fibers pass air at a drastically greater rate than normal diffusion, resulting in significant pressure decay. The intact US Filter system with no fiber breaks displays a PDT rate of ~0.5 psi/minute. To quantify the broken fiber problems observed during this study, on March 4, 2003, a pressure decay was performed on the system resulting in a decay rate of ~2.3psi/minute. Thereafter, between 30 and 35 fibers, were repaired on one of the four modules in the system. Each original CMF-S module contained ~14,500 Fibers. Figure 9 below demonstrates that the unit had broken fibers over most of trials I - III of the study. Figure 10 displays air passage during a pressure decay test through the crack that developed in the module epoxy.

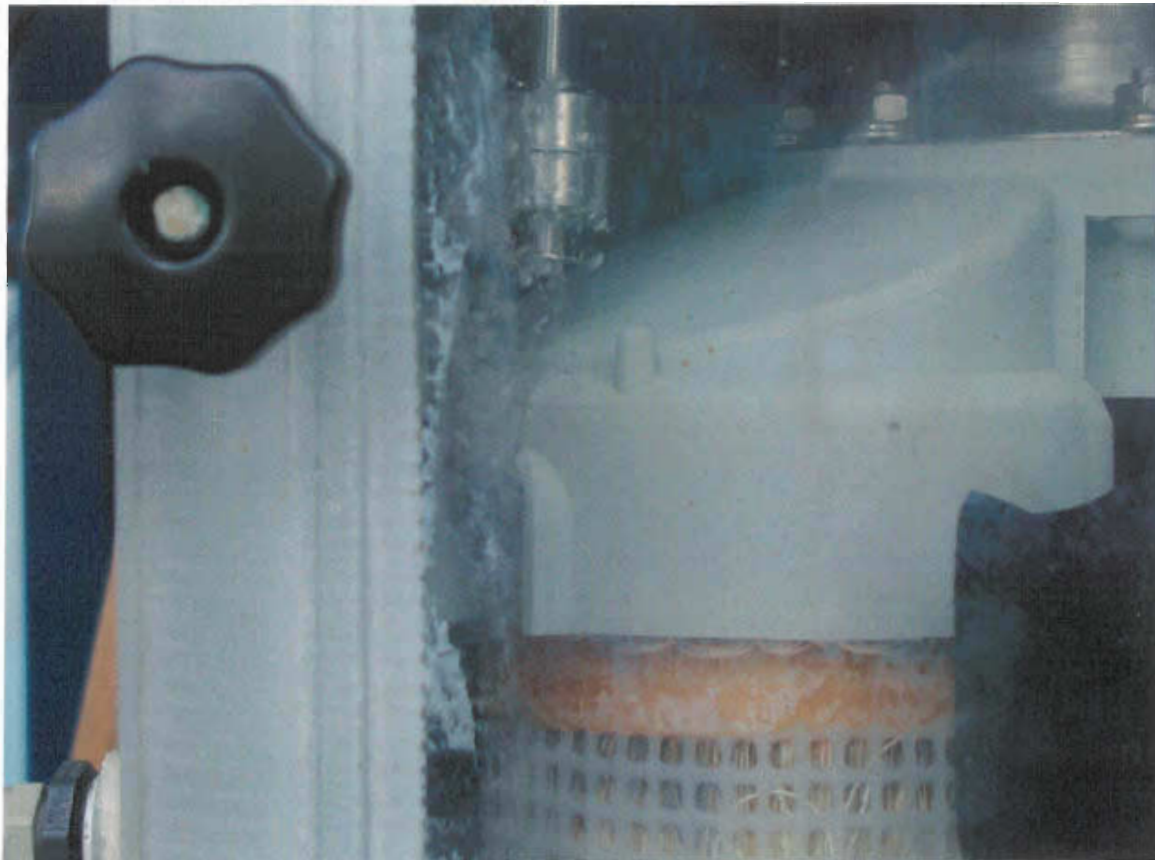
Figure 10 - Air Bubbles Emitted from the Cracked Epoxy During the Pressure Decay Test

- A. The epoxy crack was probably a manufacturing problem resulting from an incorrect epoxy mixing or curing procedure.
- B. When the flow distribution screen was removed from the end of the module, particles were found covering 20 mm of the fibers at the bottom. The particles consisted of sand and broken shell fragments that apparently passed through both the 800 um coarse strainer and the standard 500 um strainer on the CMF-S unit. It was noted that a number of broken fibers were punctured by what appeared to be sharp objects. It is possible that the broken shell fragments are a cause for some of the fiber breakage problems. Note that a 130um Arkal strainer replaced the original 500um strainer in front of the MF to alleviate this. See the appendix for further details.

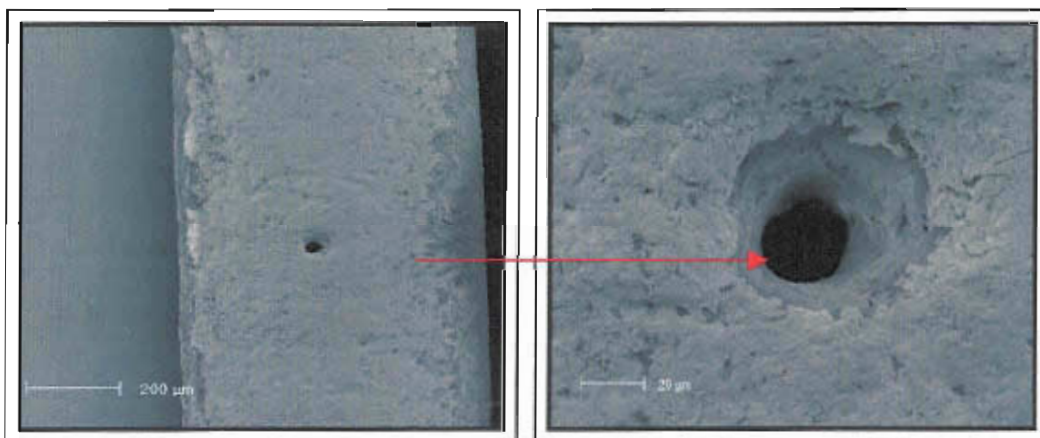
Figure 11 - SEM Photographs of a Hole in a CMF-S Module Fiber

- C. Twenty four fibers were analyzed for fiber break extension or fiber strength. The fiber strength had decreased by 20 - 40%. SEM photographs showed that other broken fibers that had sheared appeared to have been stretched before failure.

A hole in fibre found 490mm from the top. A closer look at the hole shows it appears to have been caused by a sharp object, or by something wearing into the fibre

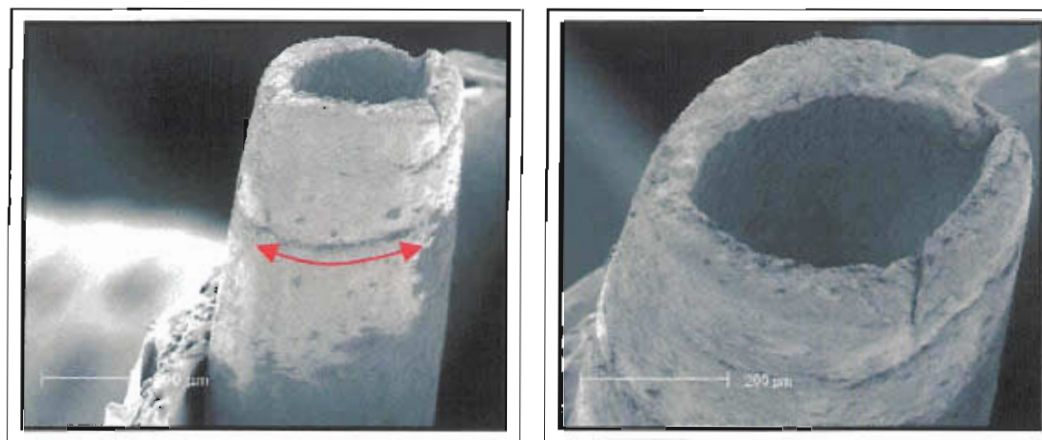
Figure 12 - Sheared CMF-S Fiber Shows Evidence of Stretch Failure

Broken fibre found 350mm (fibre 2) from the bottom. The fibre has been bent and the surface appears stretched.

The fiber stretching and the fact that three of the six modules displayed no epoxy and very little fiber breakage problems, provided evidence of a module manufacturing problem.

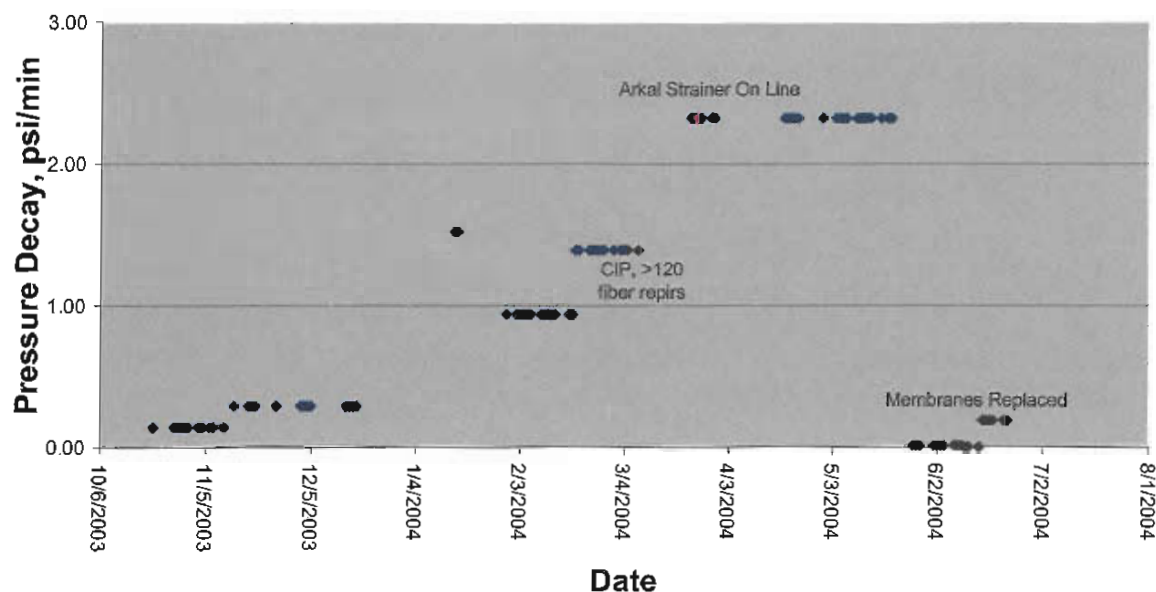
Figure 15 - Integrity of Redesigned CMF-S Modules

On May 28, 2004, all four redesigned CMF-S modules were replaced due to numerous fiber breakages. Note that these newly designed modules had been run for a significant period of time with only the 800 um strainer as pretreatment as the 130 um Arkal Spin Klin strainer was bypassed due to installation problems. However, it is clear the new module design may have allowed a significantly higher stable operating flux, but the more robust modules with only the 800 um strainer as pretreatment did not maintain integrity per figure 15.

The Arkal Spin Klin strainer was placed on line in late March, prior to the installation of the second set of redesigned modules installed on May 28, 2004. The facts that the damaged module pressure decay did not worsen (figure 15) and the replacement modules have held their integrity with the additional 130um strainer as pretreatment is promising. Additional run time with the Arkal strainer would have been required to determine if it would have prevented further MF fiber breakage.

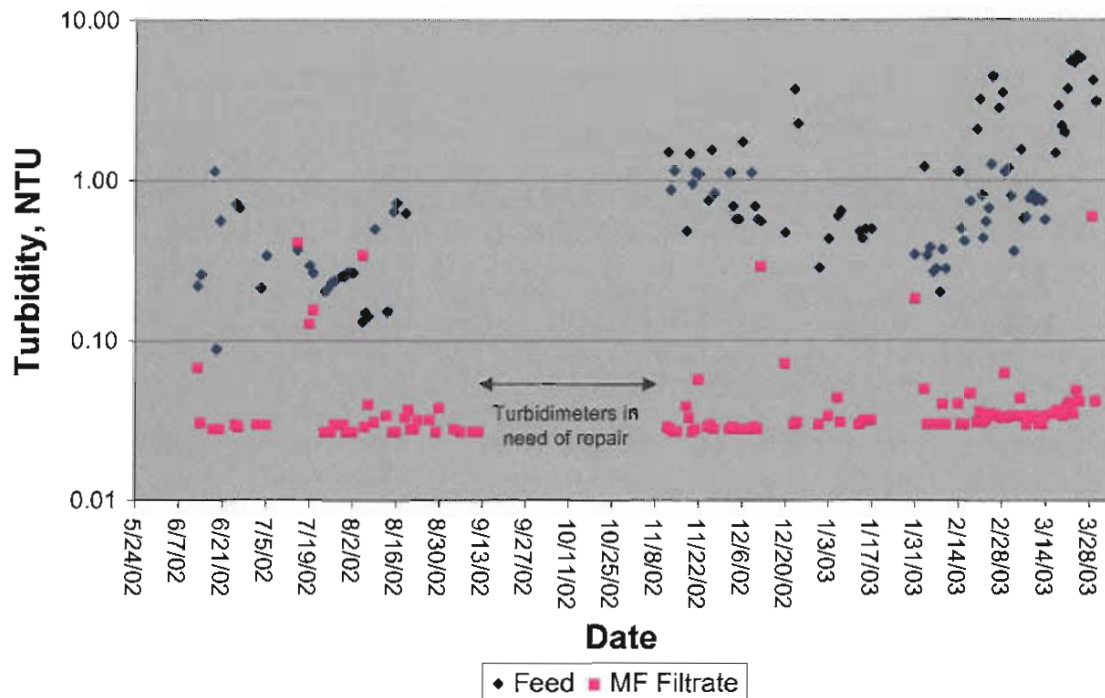
Figure 16 - Feed Water and Microfiltration Filtrate Turbidity-MF Trials I - III

The presence of suspended material in water causes cloudiness which is known as turbidity.⁶ The raw ocean water and MF Filtrate turbidities were measured once per day at the test site. The incoming ocean water turbidity has averaged ~1NTU, with peak values of ~5NTU. Per figures 16 and 17, the filtrate turbidity averaged 0.05NTU and typically was <0.1NTU, suitable for RO despite the module and fiber problems.

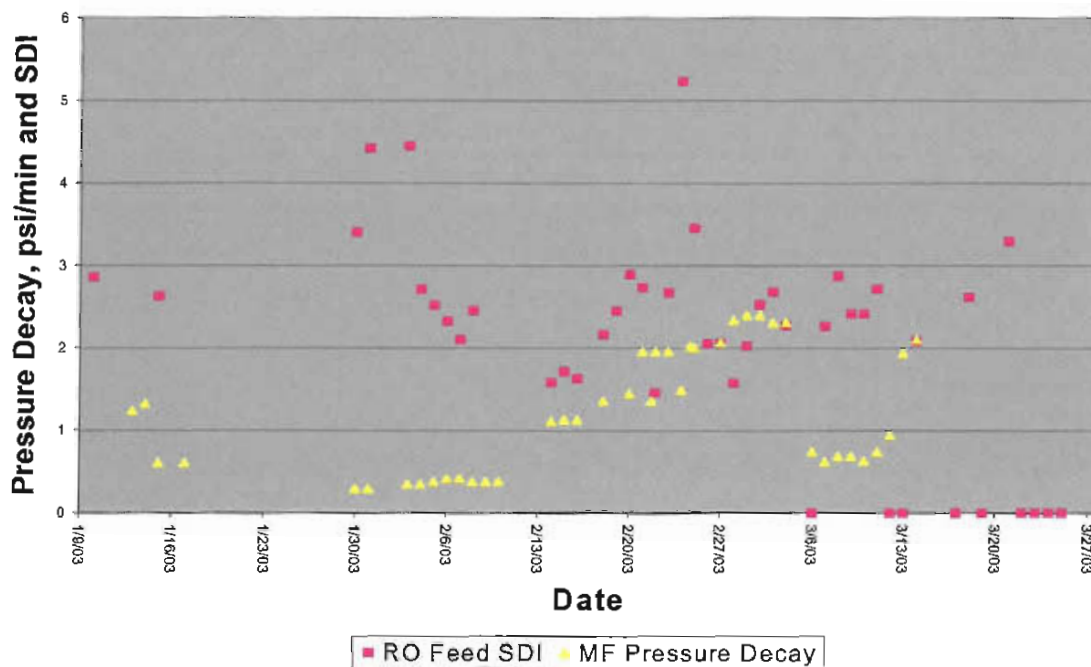
Figure 18 - MF System Pressure Decay Results and Filtrate SDI MF Trials I - III

The SDI_{15} of the raw ocean water was measured on a few occasions and was immeasurable, clogging the SDI pad significantly within 5 minutes and almost completely by the fifteen-minute mark. However, the CMF-S system proved to be quite effective at SDI_{15} reduction, typically producing water with an SDI_{15} between 2 and 3. Figures 18 and 19 show the RO Feed SDI_{15} and MF pressure decay. A trend between these two parameters is not clear in MF Trials I - III, but the graph for MF Trials IV & V demonstrates that the SDI_{15} did increase to unacceptable levels when the pressure decay on the MF system exceeded 2psi/minute. Note that the SDI_{15} reduced to less than 2 after the replacement modules were implemented on May 28, 2004. It is therefore important to find a solution to the fiber breakage events not only because of operating and maintenance efforts required to repair the fiber breaks but to ensure the water quality leaving the MF system is suitable for spiral wound reverse osmosis membranes as well.

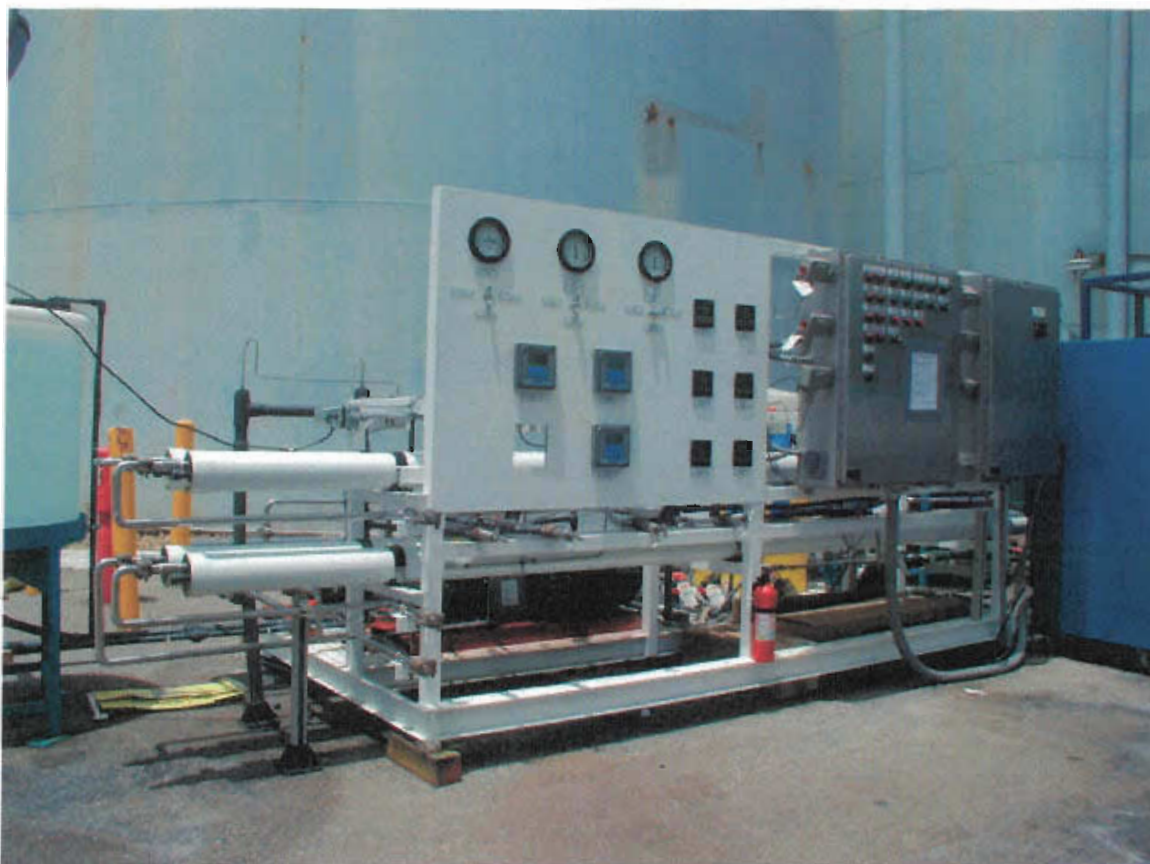
Figure 20 - Reverse Osmosis Test Equipment

The RO System utilized for this study has two independent trains of 4M, four-inch pressure vessels in a 1:1 array. To feed the seven 4" RO membranes in series, the RO pumps produce ~10 gpm at 1000 psig, and this flow/pressure combination was not readily available in a centrifugal pump. Wanner Engineering offers a positive displacement type pump with superaustenitic stainless steel wetted parts that withstands the corrosive seawater environment. These Hydracell pumps have three pistons that are alternately moved by a wobble plate. The pistons are filled with oil on their return stroke. The oil balances the back side of the diaphragms causing them to flex forward and back as the wobble plate moves. This provides the pumping action.

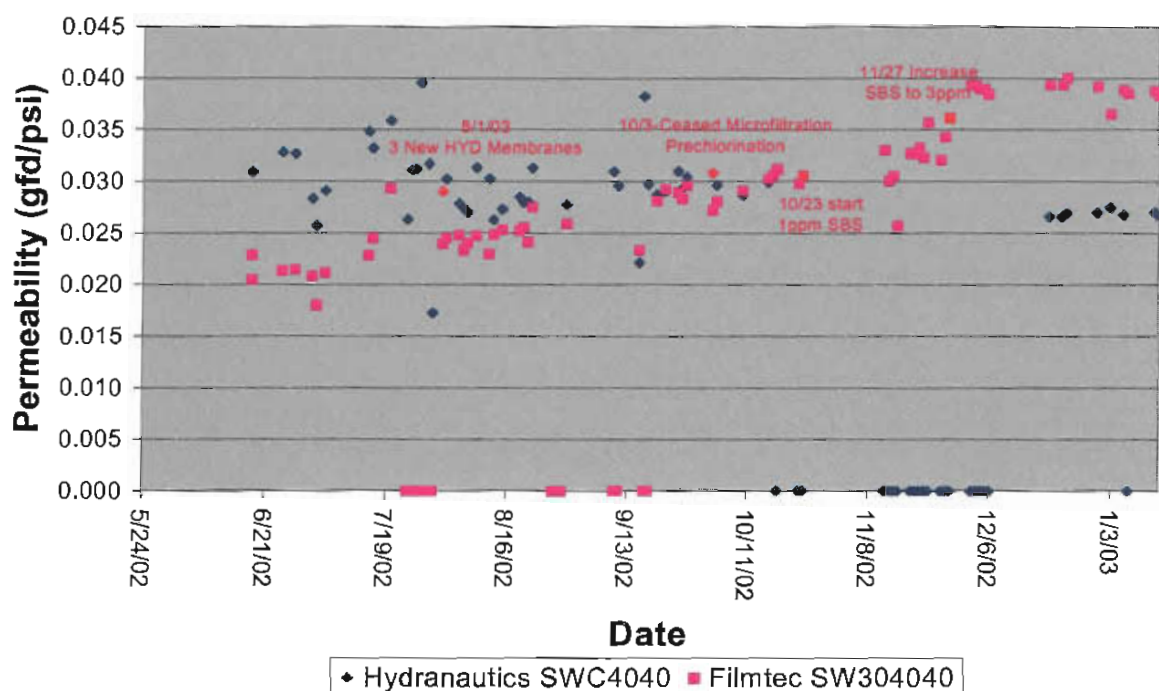
Figure 21 - Increasing Permeability of RO Membranes due to Oxidation (RO Trial I)

As depicted in Figures 21 and 22, this $\text{NaOCl} \rightarrow \text{MF} \rightarrow \text{NH}_4\text{OH} \rightarrow \text{RO}$ process failed to protect the RO membranes from oxidation. The specific flux and permeate conductivity of RO Train #1 (Dow membranes) started rising almost immediately. Train 2 (Hydranautics) proved to be more resistant, but after ~100 days of operation it was clear that the salt passage or permeate conductivity of this membrane was rising as well. On September 1, 2002 the NH_4OH addition rate was increased 50% to 1.5 mg/L in an effort to ensure that excess ammonia was present and prevent the presence of free chlorine. This did not alleviate the problem and the permeate conductivity continued to rise. In response to the RO deterioration, on October 3, the continuous chlorination in front of the MF was discontinued. Subsequently, attempts were made to run without any chlorine in the process and rapid MF fouling was observed (MF Trial II). Chlorine in the 20 - 40 mg/L range was then utilized in the MF backwash, an intermittent operation. An additional “rinse” step was added to the MF backwash to ensure no chlorine carryover to the RO. This, combined with the addition of sodium bisulfite in front of the RO was utilized in the remainder of the trials. (RO Trials II-IV).

As depicted in Figures 21 and 22, this $\text{NaOCl} \rightarrow \text{MF} \rightarrow \text{NH}_4\text{OH} \rightarrow \text{RO}$ process failed to protect the RO membranes from oxidation. The specific flux and permeate conductivity of RO Train #1 (Dow membranes) started rising almost immediately. Train 2 (Hydranautics) proved to be more resistant, but after ~100 days of operation it was clear that the salt passage or permeate conductivity of this membrane was rising as well. On September 1, 2002 the NH_4OH addition rate was increased 50% to 1.5 mg/L. This did not alleviate the problem and the permeate conductivity continued to rise. In response to the RO deterioration, on October 3, the continuous chlorination in front of the MF was discontinued. Subsequently, attempts were made to run without any chlorine in the process and rapid MF fouling was observed. Chlorine in the 20 - 40 mg/L range was then utilized in the MF backwash, an intermittent operation. An additional "rinse" step was added to the MF backwash to ensure no chlorine carryover to the RO. This, combined with the addition of sodium bisulfite in front of the RO was utilized in the remainder of the trials.

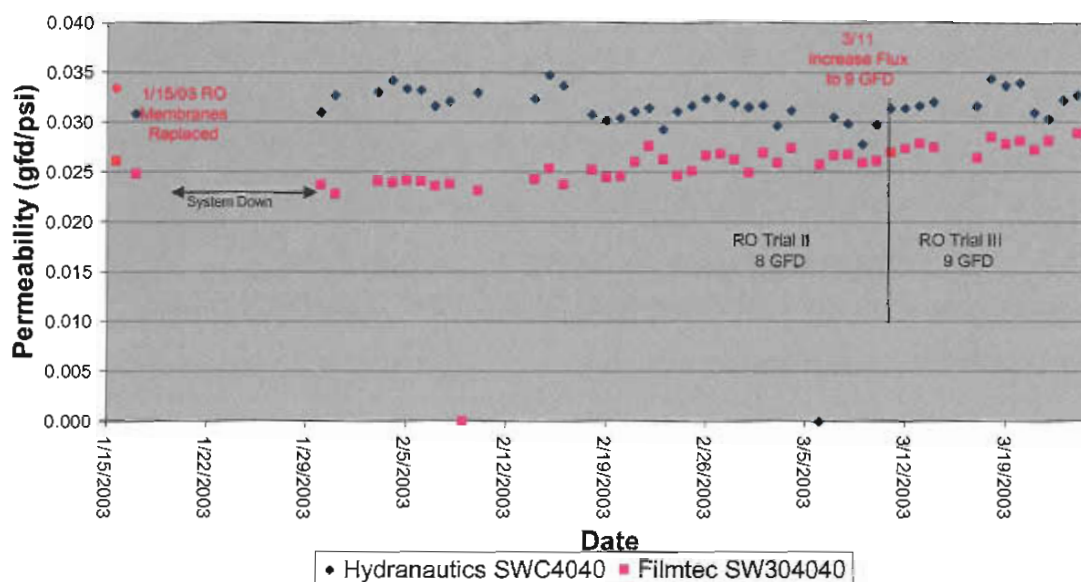
Figure 23 - Reverse Osmosis Membrane Permeability Trial II and Beginning of Trial III

Figure 23 displays that the permeability of the Hydranautics membrane was fairly stable following the replacement of the RO membranes (RO trial II). Filmtec membranes, on the other hand, showed a slight increase in specific flux and as will be discussed in the next section, permeate conductivity as well. These trends are consistent with membrane oxidation. However, the Hydranautics membranes did not show these signs of oxidation. It is possible that small amounts of chlorine (or bromine), not reduced by the sodium bisulfite, reached the RO system, and the Hydranautics membranes may be more resistant to oxidation. Likewise, examination of Figures 21 and 22 above, which display the results of the Trial I testing of the RO membranes oxidized by the $\text{NaOCl} \rightarrow \text{MF} \rightarrow \text{NH}_4\text{OH} \rightarrow \text{RO}$ process, reveals that the Filmtec membranes experienced deterioration, presumably from oxidation, much faster than the Hydranautics membranes. RO Trial III commenced in March 2003 operating at 9 GFD.

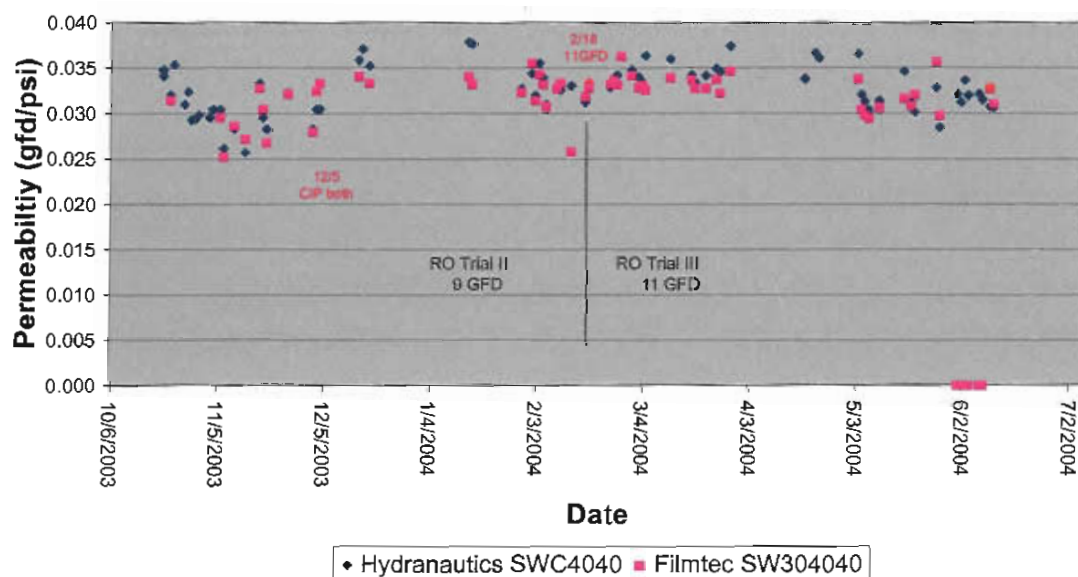
Figure 24 - Reverse Osmosis Membrane Permeability End of Trial III and Trial IV

Between April and October 2003, the trials were halted to make some mechanical changes to the RO system, namely moving the high pressure pumps to a separate skid and the addition of variable frequency drives. This is discussed further in the appendix. Testing was resumed in October 2003. A drop in permeability was immediately observed and the membranes were cleaned on December 5, 2003. The permeability decline was probably due to bacteriological growth in the RO membranes during the period of shutdown. For most of the shutdown, the membranes were periodically run and then flushed with RO permeate water. However, the RO retrofit occurred over a period of 2 months in the summertime, the power to the unit was out, and thus the membranes could not be flushed. After cleaning, the permeability was restored to pre-shutdown values and operated at 9 GFD flux. The flux was increased to 11 GFD on February 18, 2004. Comparison of the permeability between January 15, 2003 and June 2, 2004 (the end of figure 23 and the beginning of figure 24) demonstrated that both the Hydranautics and Filmtec membranes did not decrease in permeability over the course of the testing. Thus, no significant fouling was been observed on this set of RO membranes over approximately 3100 hours of testing.

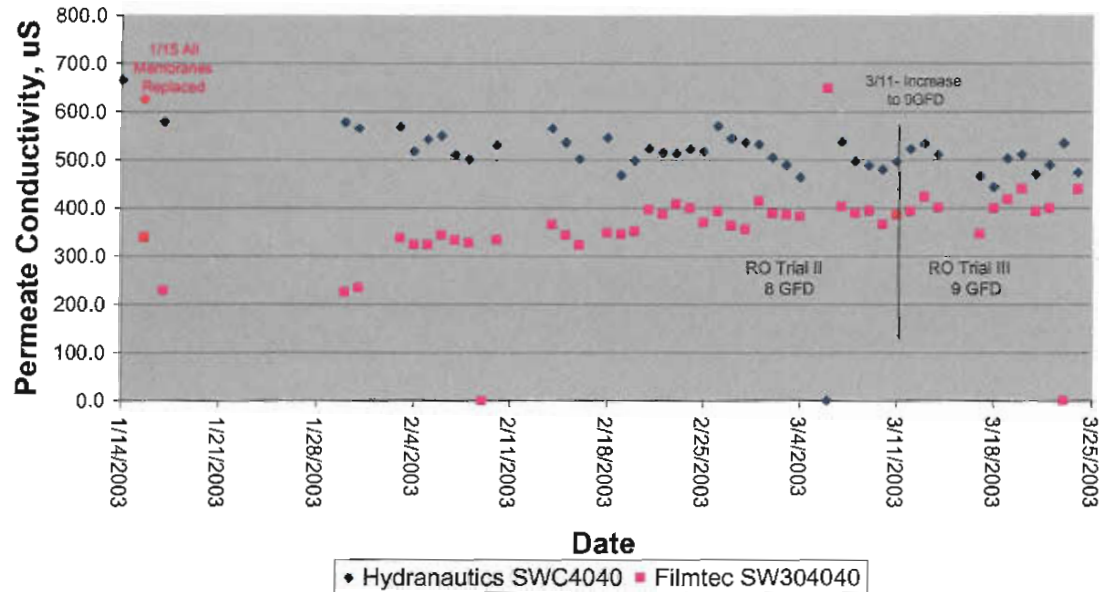
Figure 25 - Reverse Osmosis Membrane Conductivity Trials II and Beginning of Trial III

Figure 25 demonstrates that the conductivity produced by the Filmtec membrane was initially significantly below that of Hydranautics. However, during trial II, the conductivity of Dow permeate rose and the Hydranautics permeate conductivity gradually declined. By the beginning of Trial III of the RO testing, the two membranes were producing water with similar conductivity. At the end of Trial IV of the testing, each membrane was producing permeate water of about 550 uS at 11 GFD and 18°C. (Figure 26).
